Manhole Inspection Summary

Manhole # S17C1_021MH

Insp Date: **5/19/08 10:58 AM**

Location Address: **1900 deering av**

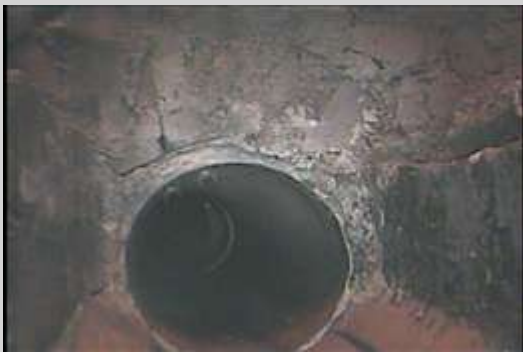
12 O'Clock Outflow

8 in. Circular Gravity Sewer
Pipe Out @ 12 O'Clock

Pipe Height: **8.4** (in.) Rod and Bar (Angled)
Pipe Material: **Clay** ☐ Pipe Lined
Invert Depth: **7.92** (ft.) Flow Characteristics: **Slow**
Deposits: ☒ None ☐ Mud ☐ Gravy ☐ Debris ☐ Grease
Silt Depth: **0** (in.) Deposits Extent:
Infiltration: **None** Pipe Seal Cond: **Sound**
